The Boscastle Flood 2004

by Phil Bull

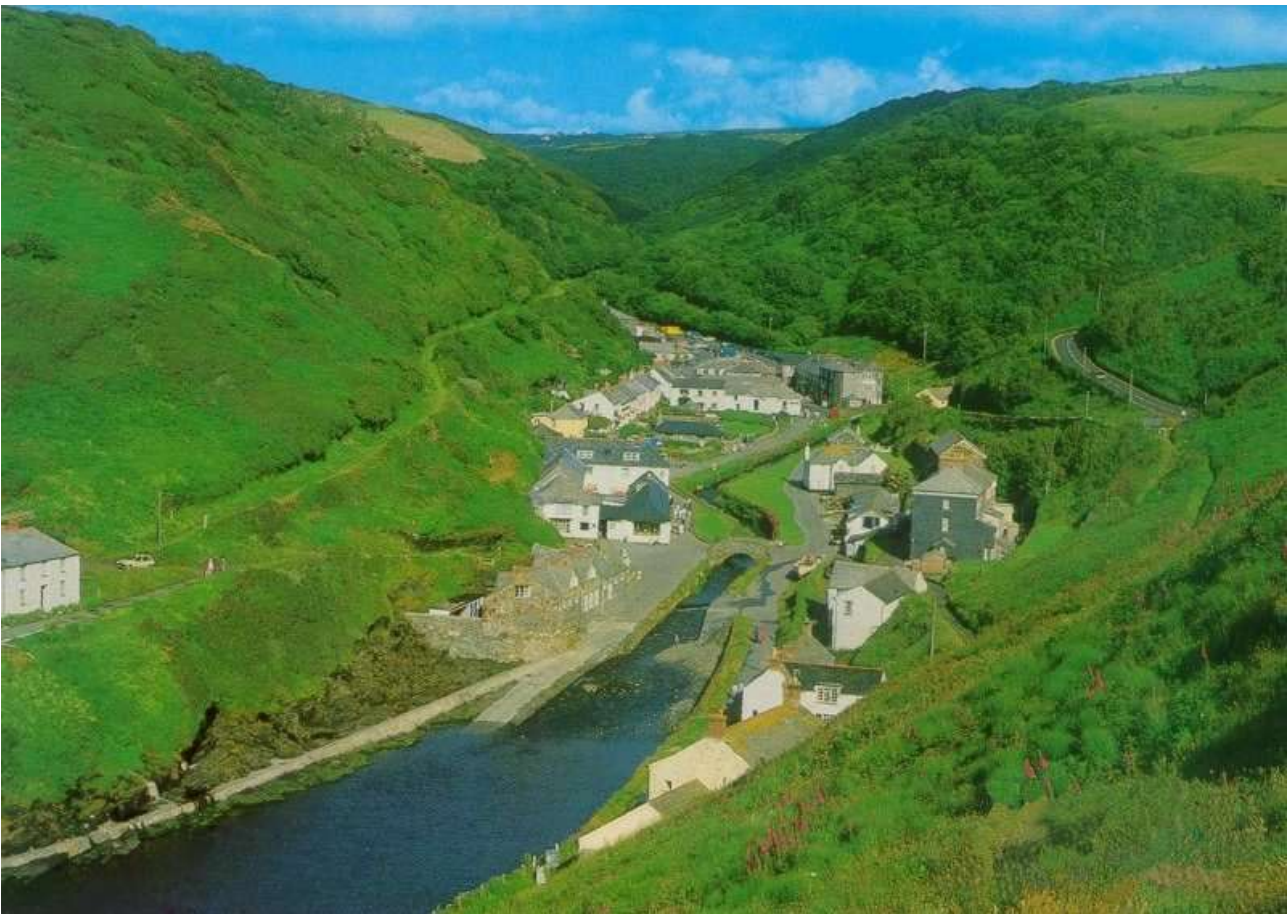
Boscastle - within the Valency Valley. Note the steep slopes & narrow river channel, which allowed massive amounts of water to flow into the same place all at once

A major factor is the location of the village, within the Valency valley. The Valency is normally a quiet stream, which follows a very steep course down into the valley from the hills around. The valley's structure is likely one of the most major physical factors, as its steepness accelerated the rainwater falling on the hills above the valley greatly as it travelled down to the valley floor where Boscastle stands. As well as causing the water to travel extremely quickly down the valley sides, the shape of the valley concentrated rainwater from the surrounding area into a relatively narrow space descending towards the valley bottom. Not only did this cause an increase in run-off speed, but also an increase in discharge volume, which was later to prove devastating in the confined river channel flowing through the village itself, which simply couldn't hold enough water to prevent the flooding which occurred.

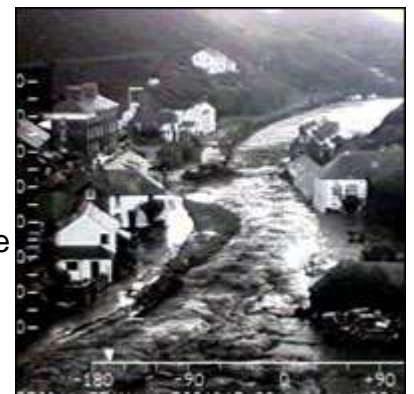
View from helicopter showing the extent of the flooding

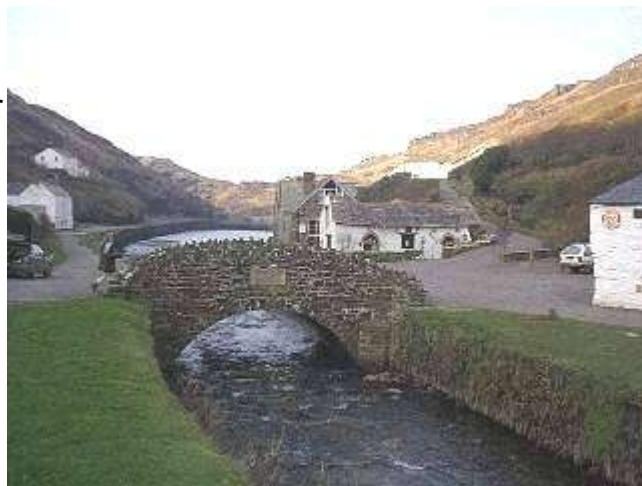
The bridge in the centre of the village, under which debris became lodged, blocking off the channel & increasing the reach of the flood waters

Also, structures obstructing the course of the river increased the spread of the floodwater. The most obvious of these is the bridge in the centre of the village, under which cars &

vegetation became stuck. Because the flow of water was partially blocked, some water had to flow around the bridge, flooding properties further from the river channel than perhaps would have been had the obstruction not occurred.

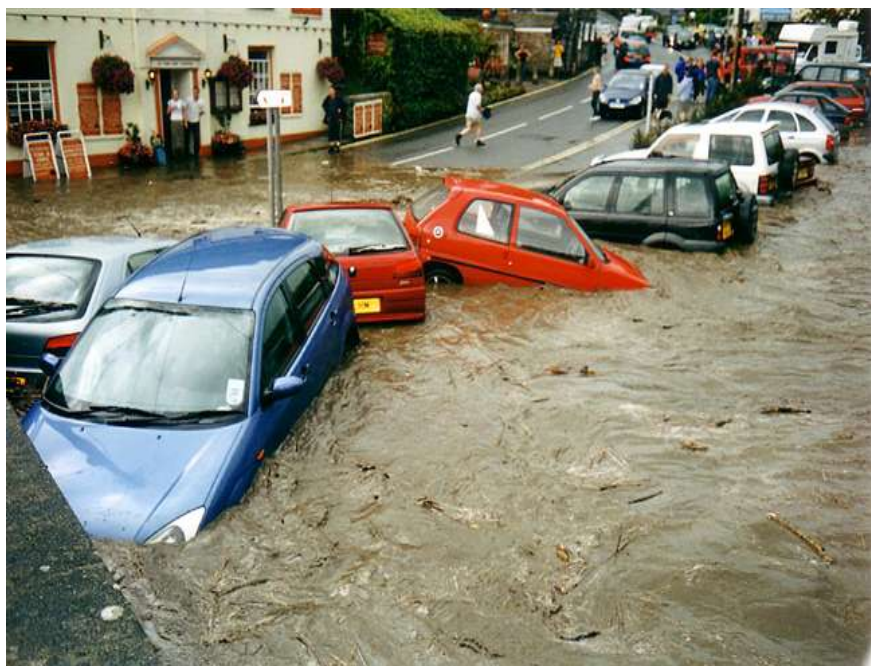
Cars & other vehicles were swept up by the floodwater & taken out to sea. Some collided with buildings, causing severe structural damage.

- Property was destroyed by debris such as entire trees & vehicles speeding down the valley at high speed, pulled out towards the sea by the raging torrent. Buildings were smashed, especially in the main street where the river channel flows.

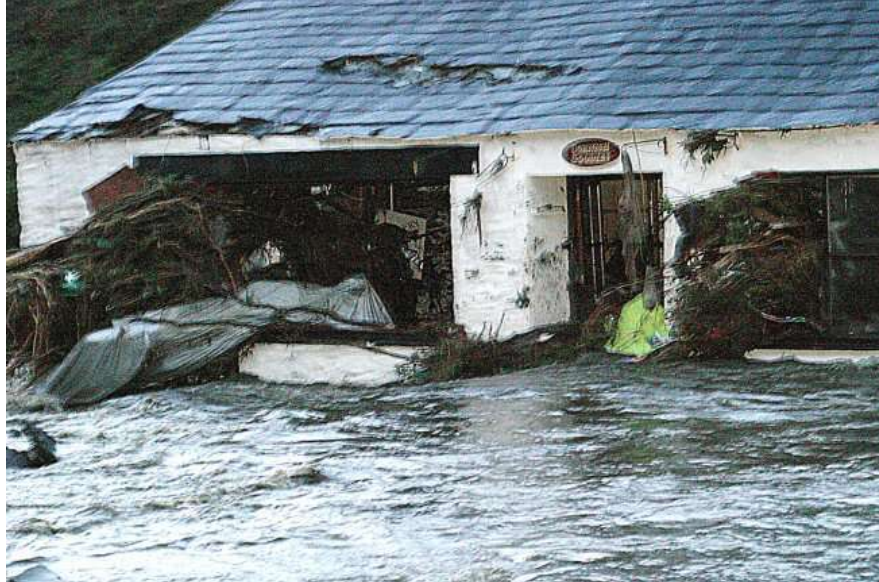
The witchcraft museum & local shop, Boscastle's greatest tourism assets, were left beyond repair by the flood

Buildings nearest the river channel remained deep in deposited silt & debris & were in some cases too damaged to salvage. The museum & a shop were the worst affected, the shop being hit directly by a tree, so demolition was the only option in this case.

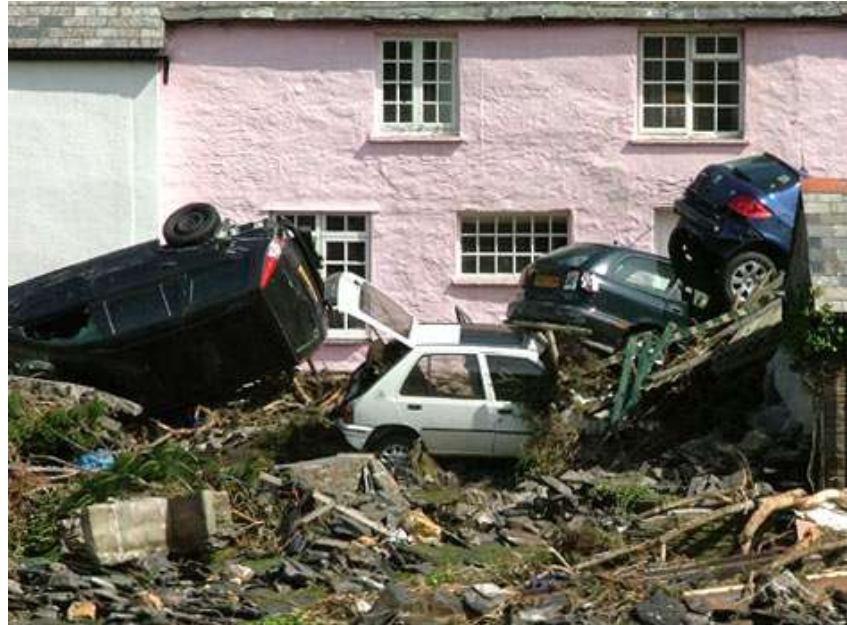
Removing rubble & debris was the principal concern once the flood waters had drained away, as many buildings were left inaccessible by their presence

Since August, the focus has been on the clean-up operation in Boscastle. The initial stages of the clean-up were to secure buildings damaged by the flooding, as these posed the most immediate risk to public safety. Building inspectors were called into the area & the entire centre of the village cordoned off from the public. The entire process of inspecting & securing buildings took several days, after which home owners were allowed to retrieve any possessions they could salvage.
